# Community Preservation Committee Town of Arlington

Project Title: **Study of Spy Pond Field Bleachers**

## **SPY POND FIELD Assessment of Concrete Bleachers**

### **Final Report**

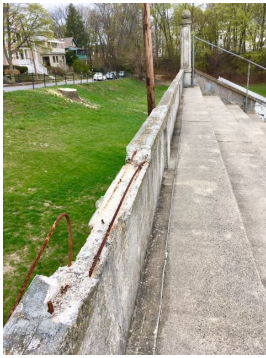
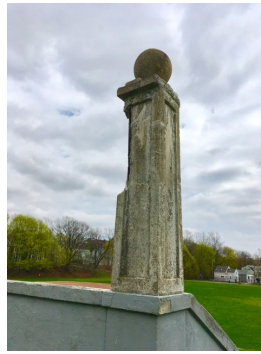
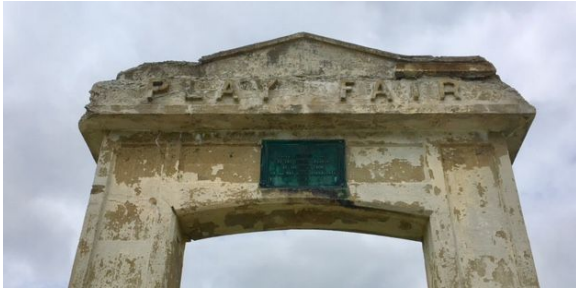
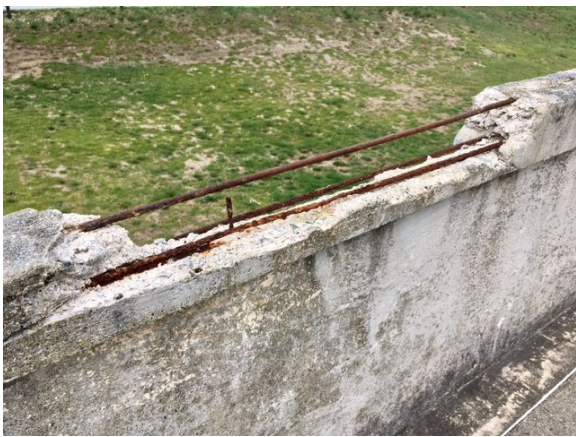
Stadium Structure	
<p><i>2014 Assessment</i></p> <ul style="list-style-type: none"> <li>• Crumbling concrete</li> <li>• Exposed rebar</li> </ul>

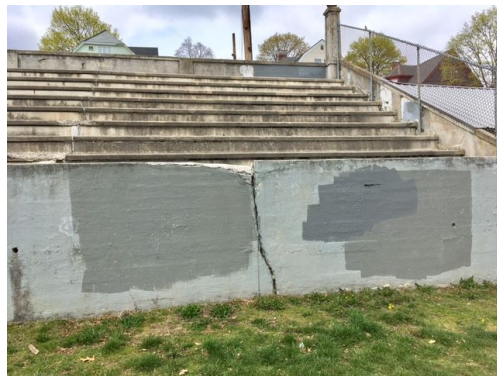
### Graffiti/Tagging

All vertical surfaces are regularly tagged.

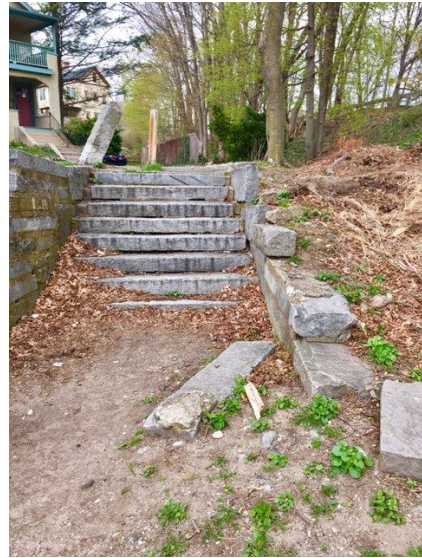
### Stairs at end of Lombard Terrace

Granite wall on right is unstable due to erosion.

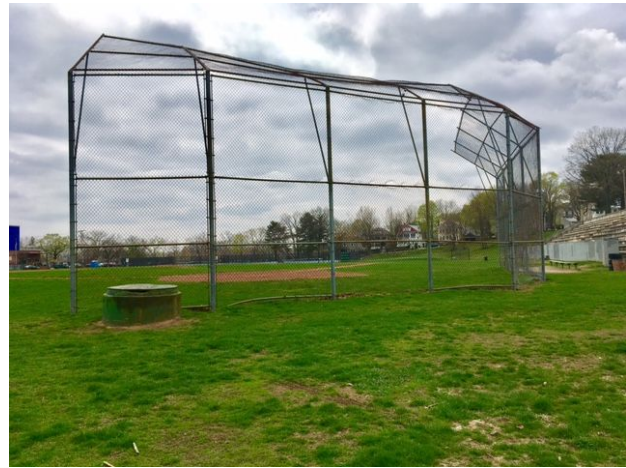
Disrepair backstop and dugout building.

Chain link is bent with holes and portions bending out.

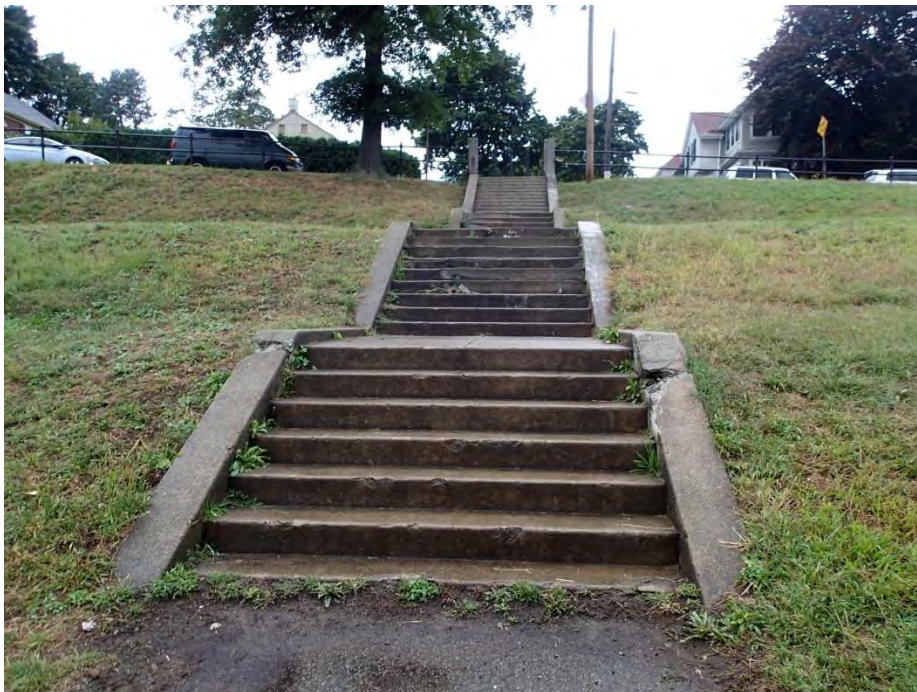
*Figure 4. Site stairs leading from Lombard Terrace down to field level.*

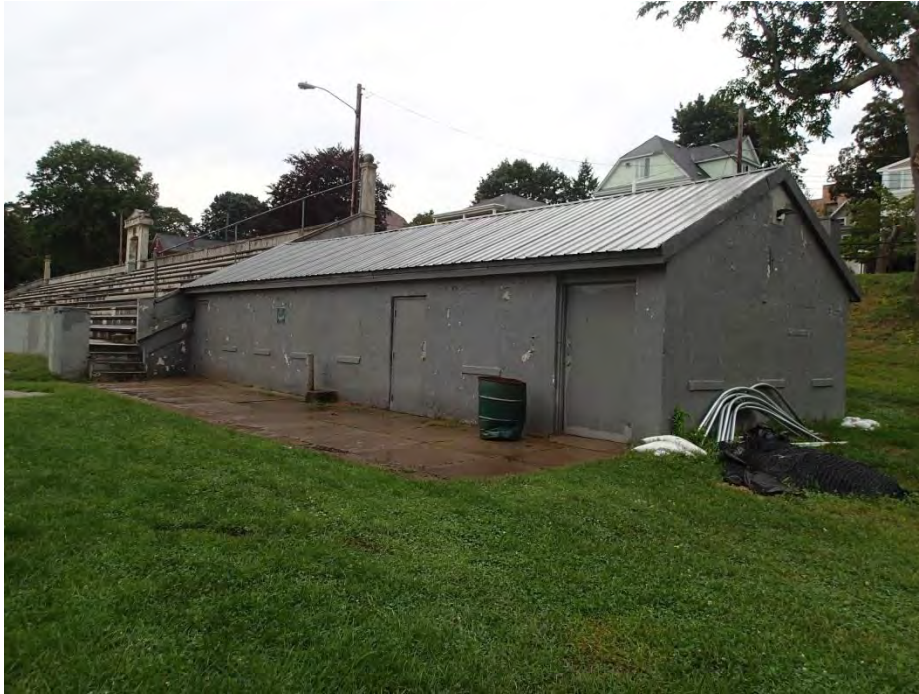
The remaining portion of the maintenance and locker room building lies outside of the bleachers and is covered by a corrugated sheet metal roof (Figure 33). There is a large horizontal crack at the northeast corner of the building measuring approximately 1/2-inch wide with peeling coating on all three sides of the building (Figure 34).

*Figure 33. Portion of locker room and maintenance building that lies outside of the bleachers.*

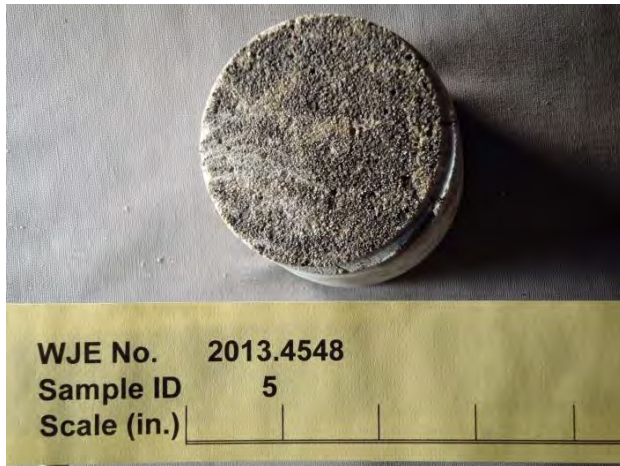
*Figure A17. The as-received appearance of the top of Core 5 is pictured using low-angle lighting.*

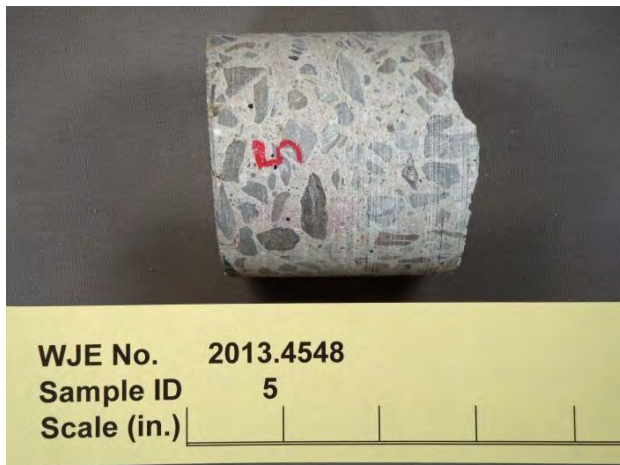
*Figure A19. The as-received appearance of the side of Core 5 is pictured.*

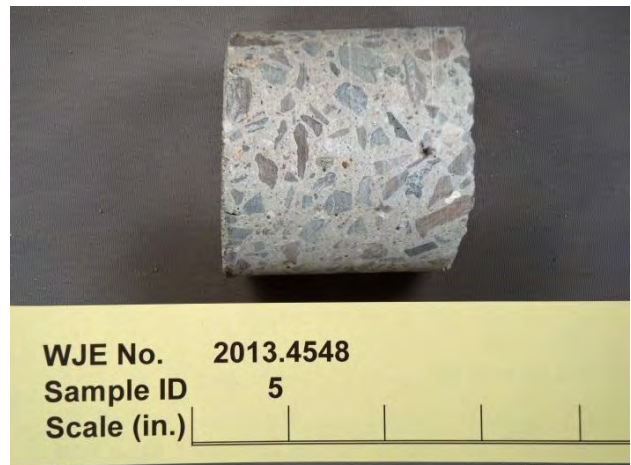
*Figure A20. The as-received appearance of the side of Core 5 is pictured.*

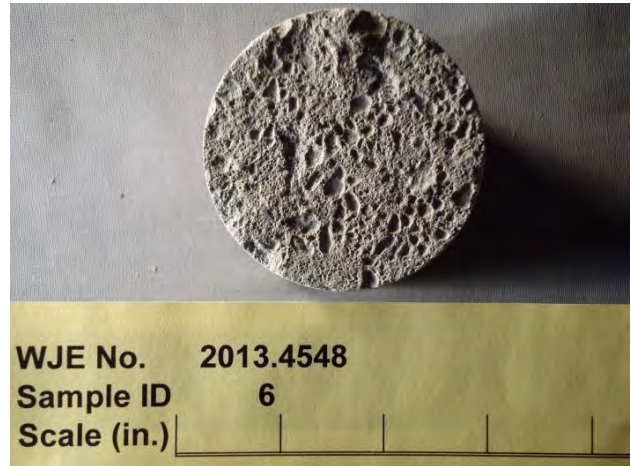
*Figure A22. The as-received appearance of the top of Core 6 is pictured using low-angle lighting.*

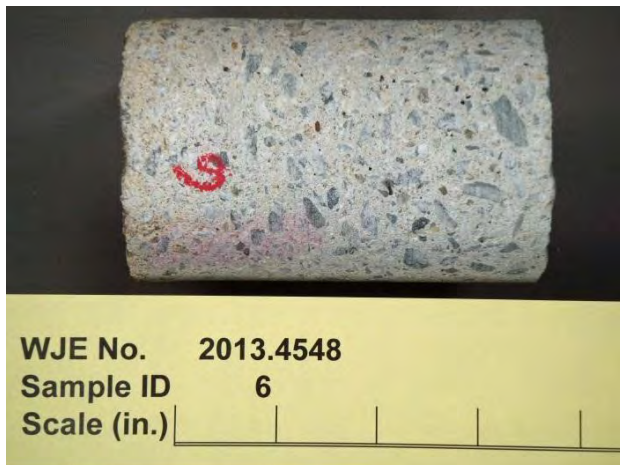
*Figure A23. The as-received appearance of the side of Core 6 is pictured.*

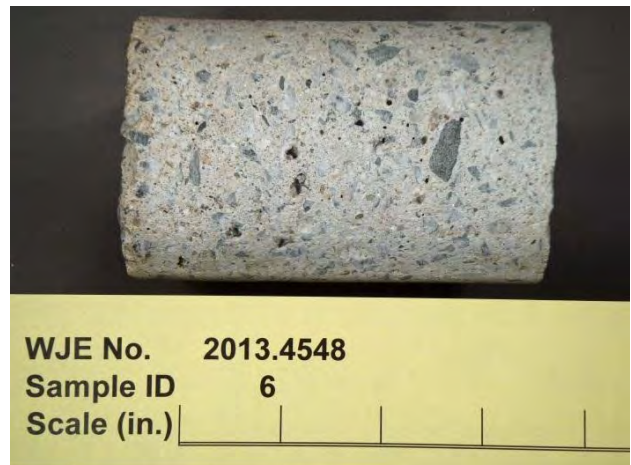
*Figure A24. The as-received appearance of the side of Core 6 is pictured.*

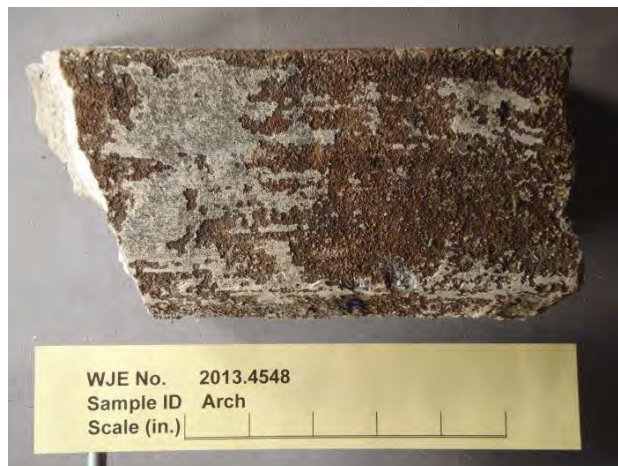
*Figure A26. The as-received appearance of the side of the Arch is pictured using low-angle lighting.*

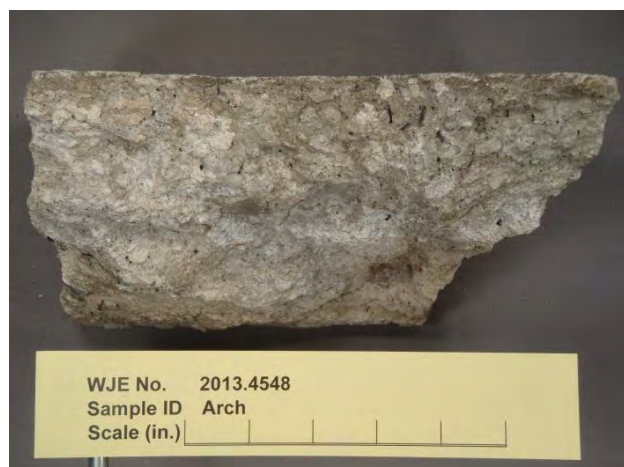
*Figure A27. The as-received appearance of the side of the Arch is pictured.*

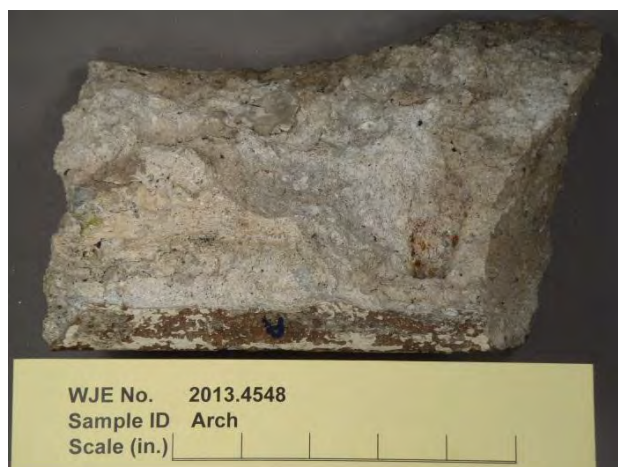
*Figure A28. The as-received appearance of the side of the Arch is pictured.*

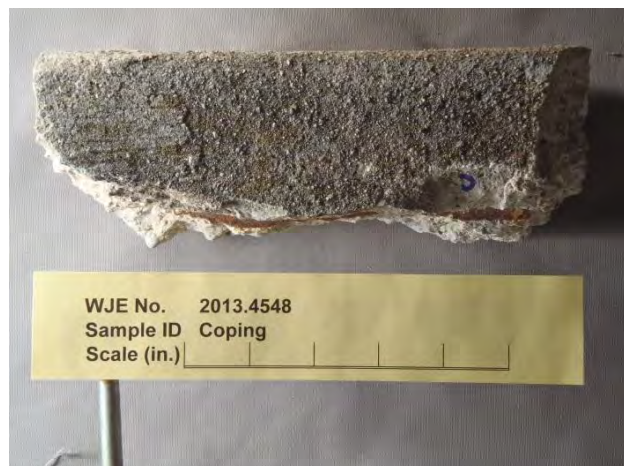
*Figure A29. The as-received appearance of the side of the Coping is pictured using low-angle lighting.*

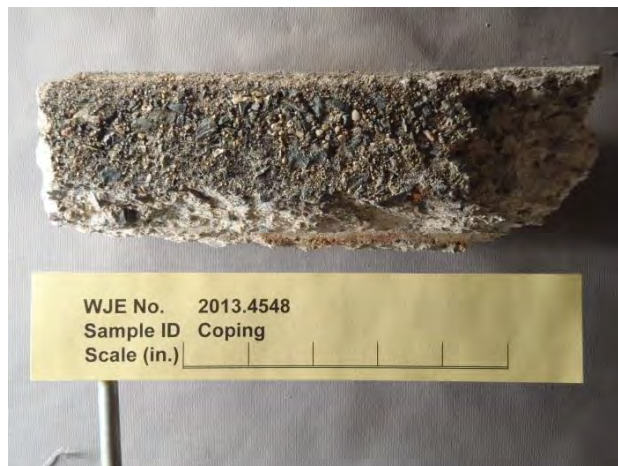
*Figure A30. The as-received appearance of the side of the Coping is pictured using low-angle lighting.*

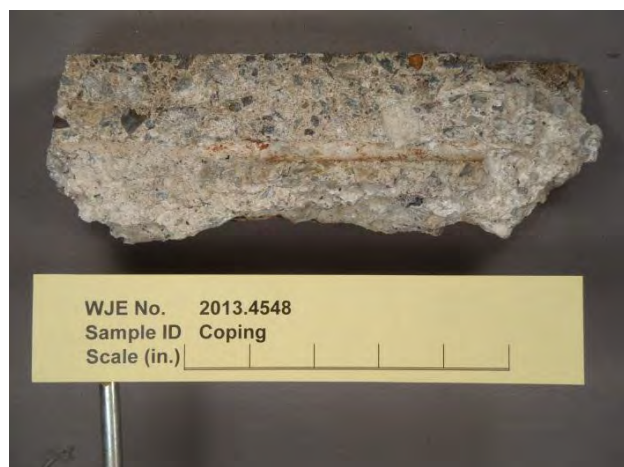
*Figure A31. The as-received appearance of the side of the Coping is pictured.*

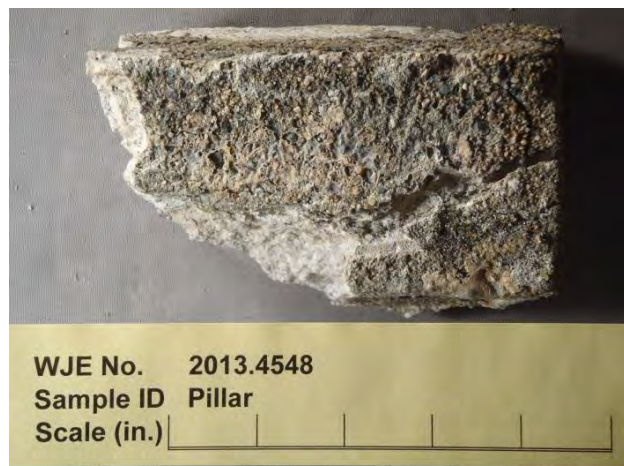
The pillar sample is not air-entrained and exhibited severe distress that appears to be related to freeze-thaw damage (Figure 18). Voids were partially filled with white secondary deposits.

*Figure A33. The as-received appearance of the side of the Pillar is pictured using low-angle lighting.*

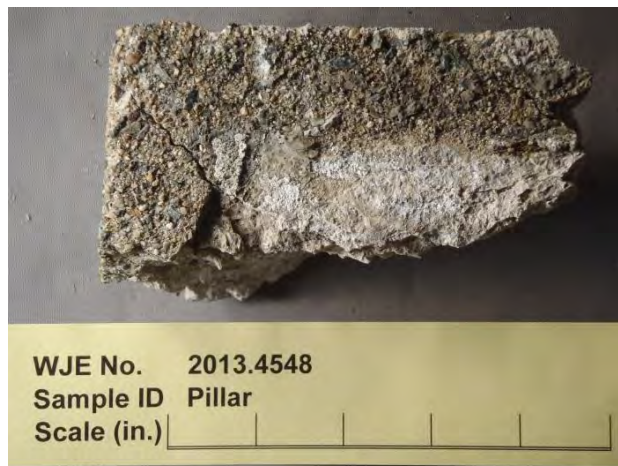
*Figure A34. The as-received appearance of the side of the Pillar is pictured using low-angle lighting.*

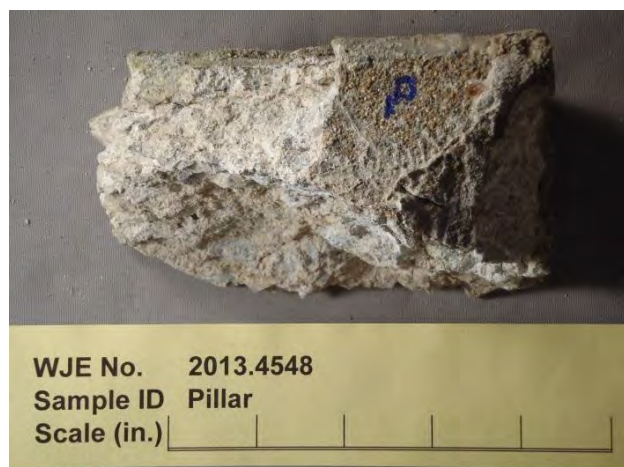
*Figure A35. The as-received appearance of the side of the Pillar is pictured.*
